**Flood Control Project Maintenance
Levee Inspections**
LMA District Cover Sheet
Spring 2019 Levee Inspection Results

Levee District No. 0009 (Sutter County)

Levee Inspection Report By Mile - Spring 2019

Waterway	Bank	Unit Miles	Inspection Start/End	Inspector
Unit No. 01 Sutter County, Feather River	Right	6.25	04/12/2019 04/12/2019	Sterling York

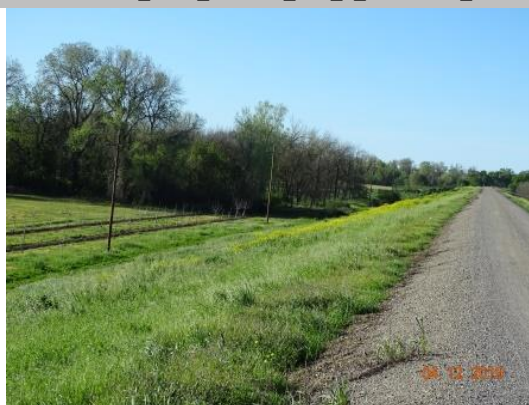
Photo 1 of 1 : SP_2019_LD0009_202_2_20190415_00004.jpg

LM Start	0.00	Rating **	M	Issue No.	2
LM End	6.23	Issue Type +	Ma	Location *	WS
Category	Earthen Levee			GPS Latitude/Longitude	
				Start	End
Item	Vegetation			39.168827 °	39.255559 °
				-121.622585 °	-121.636350 °
DWR ID	DWR_LD0009_01_s_2019_2				
Comment Code					
V1 : Control annual grass and weeds on the levee slopes and easements.					
Inspector Comment					
The annual vegetation is too high to be able to see any new issues and should be maintained before the fall inspection.

View looking downstream waterside at the annual vegetation that needs to be better maintained, Spring 2019.

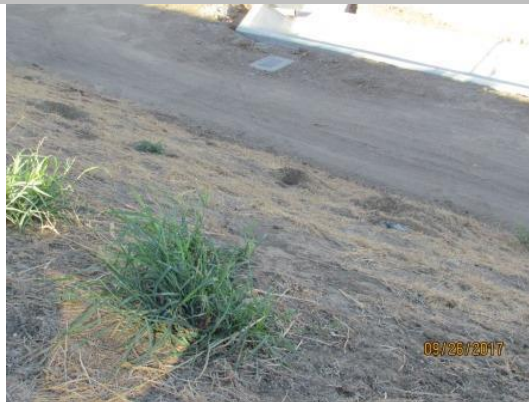
Photo 1 of 1 : SP_2019_LD0009_202_18_20190305_00001.jpg

LM Start	0.09	Rating **	M	Issue No.	18
LM End	0.09	Issue Type +	Ma	Location *	LS
Category	Earthen Levee			GPS Latitude/Longitude	
				Start	End
Item	Animal Control			39.170064 °	39.170064 °
				-121.622563 °	-121.622563 °
DWR ID	DWR_LD0009_01_f_2016_18				
Comment Code					
A3 : No rodents visible, but rodent burrows visible; need to backfill and compact or grout burrows.					
Inspector Comment					
No rodent activity was observed, holes need to be backfilled. Fall 2018

View on landside of rodent activity and holes.

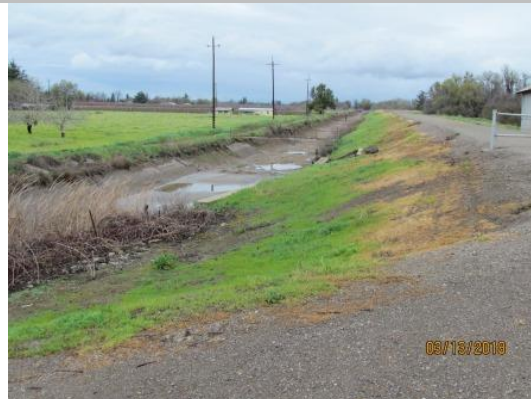
Photo 1 of 1 : SP_2019_LD0009_202_20_20190305_00002.jpg

LM Start	5.66	Rating **	M	Issue No.	20
LM End	6.00	Issue Type +	En	Location *	LS
Category	Earthen Levee			GPS Latitude/Longitude	
				Start	End
Item	Encroachments			39.247349 °	39.252258 °
				-121.637341 °	-121.637077 °
DWR ID	DWR_LD0009_01_f_2016_20				
Comment Code					
DT : Ditch					
Inspector Comment					
A ditch is located at the toe of the levee on the landside.

View looking upstream of ditch at the toe of the levee on the landside.
